## **Moderna COVID-19 Vaccine Recall Investigation Report – October 2021**

### **Purpose and Intent**

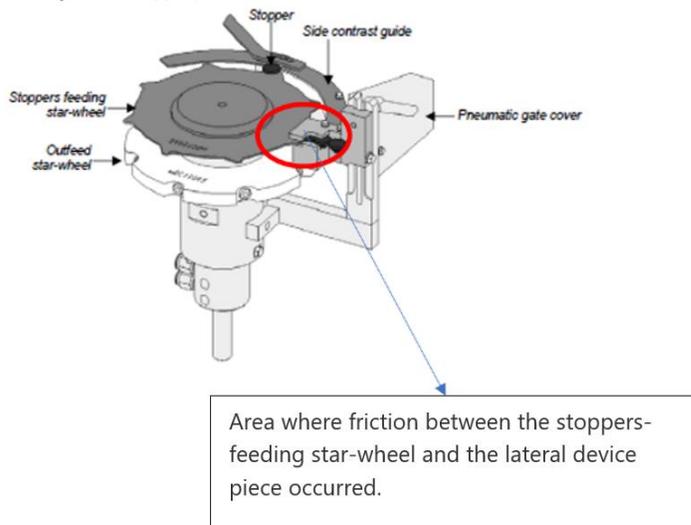
The investigation revealed that the root cause of the particles identified in Lot 1 was the friction of two pieces of stainless steel 316L installed in the stoppering station of the line due to an incorrect set up of the equipment during a manufacturing line changeover (converting the line from running one product to another product) that occurred immediately prior to Lot 1. The incorrect assembly before manufacture of Lot 1 was not resolved at a separate vial breakage intervention (as detailed below) by the line operator after the filling of Lot 3. This led to the issue persisting throughout the series of five batches. The incorrect assembly was due to human error specific to visually misjudging the precise 1mm gap between the star-wheel and the stopper. This issue had not occurred before.

The two pieces of the stoppering station are the “star-wheel” and a lateral part of the star-wheel called the “stopper feeding device.” These two elements feed and deliver the stoppers to the vials. There is a required gap of 1mm between the star-wheel and the stopper feeding device and the regulation of that gap is conducted visually. A proper alignment relies on the capability, qualification and experience of the person performing the setup. The figure below illustrates the source of the friction.

of abrasion of the star-wheel and that the equipment parts had not been correctly assembled, leading to friction of the metal parts, which generated particles.

In summary, the incorrect assembly occurred as described above – at the changeover of the line by the plant mechanic before manufacture of Lot 1, which was not resolved at the vial breakage intervention by the line operator after Lot 3. This led to the issue persisting throughout the series of five batches. The incorrect assembly was due to human error specific to visually misjudging the precise 1mm gap between the star-wheel and the stopper.

After the abrasion was observed, the star-wheel and stopper feeding device were removed once again from the line, cleaned, disinfected and re-assembled by the plant mechanic ensuring the correct assembly and verifying the required 1mm gap between the two elements. At that time, the filling of Lot 5 continued until complete. Lots 4 and 5 were investigated after Lot 4 failed inspection due to particles and were held at ROVI and never released or distributed to any market.

Moving forward, a new precision tool will help ensure that the star-wheel is assembled with the exact required 1mm gap. This is a positioning gauge that assures there is sufficient gap between the two metallic pieces and to avoid friction during the setup. Previous to this, and per the

manufacturer recommendations, the regulation of the height of the stoppers feeding device had been done visually. Furthermore, the standard operating procedure for changeover of the manufacturing line was improved and requires that only trained authorized mechanics perform all changeovers and interventions.

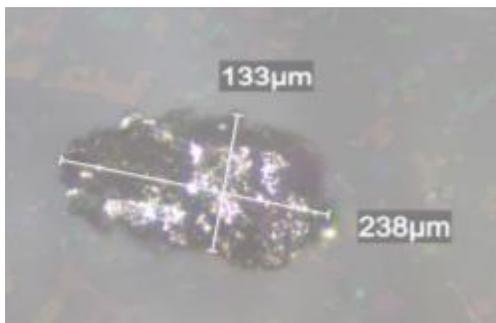
Silver-colored, metallic-like particles were found in 24 of the 26 vials in which particles were identified. Elemental analysis confirmed that all silver-colored, metallic-like particles were grade 316L stainless steel (table below). Based on the microscopic and elemental analysis, the cause of the 316L stainless steel particles in the complaint vials is specific and isolated as described in Section 2.

Microscopy results showed that all 316L stainless steel particles in the tested vials ranged in size from approximately 22 x 15 microns to approximately 697 x 410 microns.

A picture of a representative silver-colored, metallic-like particle, measuring 238 x 133 microns, is provided below.
